Enequist Chemcial Co., Inc. Draft Upland Site Summary

ENEQUIST CHEMICAL CO., INC. (DAR SITE ID #8)

Address: 100 Varick Avenue, Brooklyn, Kings County, New York 11207

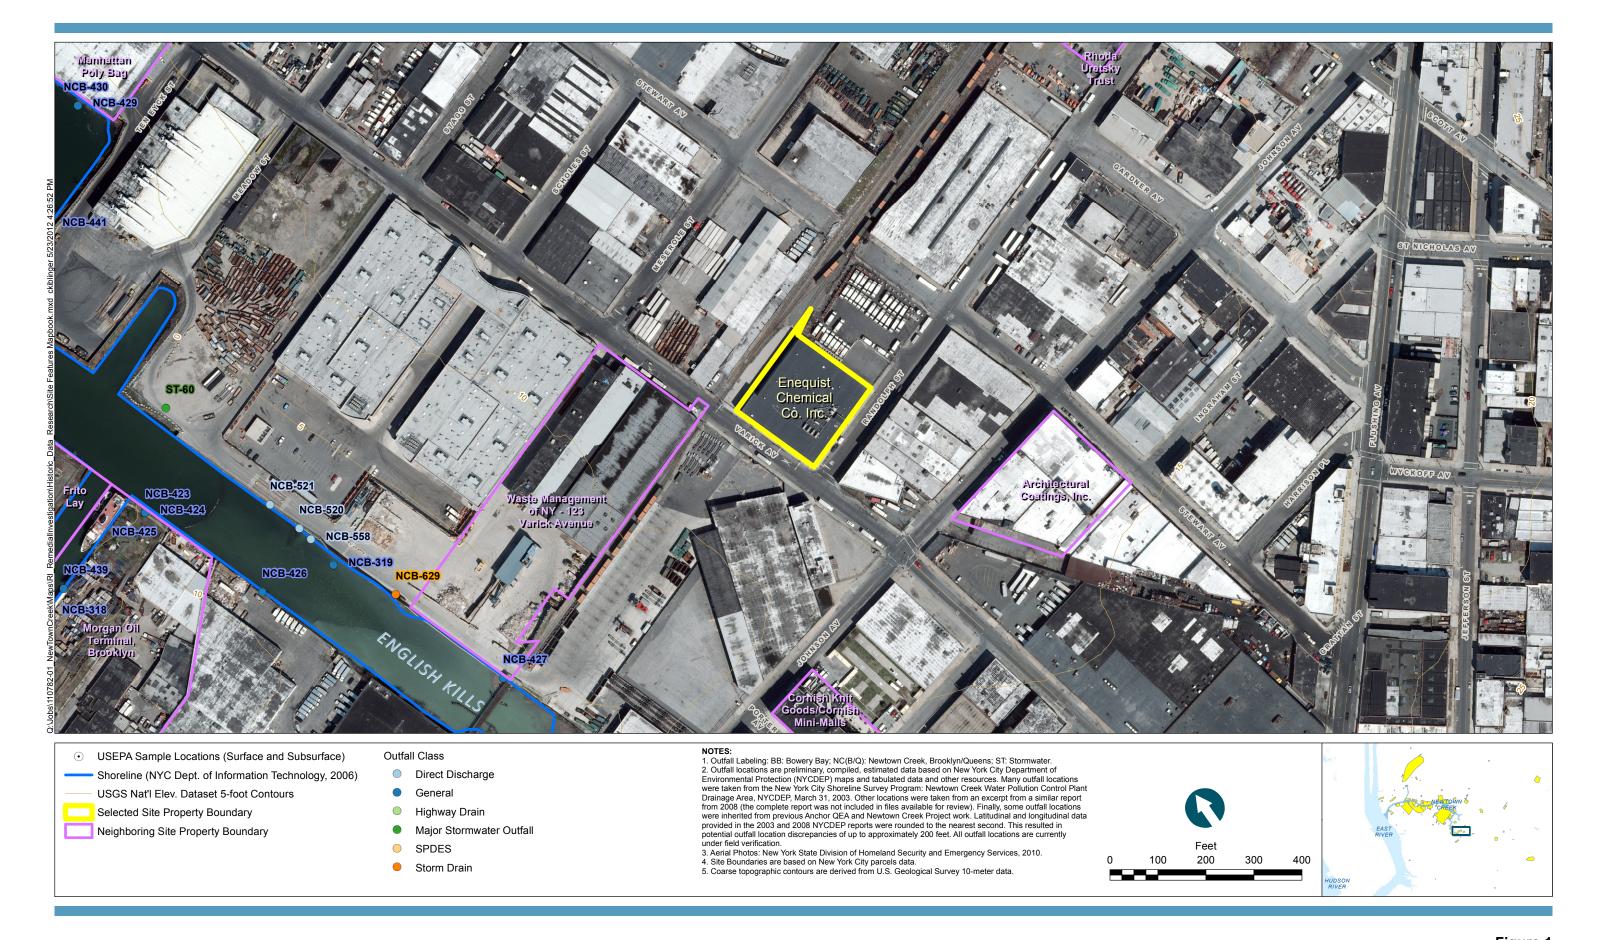
Figure 1 Site Vicinity Map: Enequist Chemical Co., Inc.

The site and the surrounding area is zoned manufacturing. The site is located close to two other environmentally regulated sites; Waste Management of New York and The Print House/Architectural Coatings, Inc. (see Figure 1).
